Smoke and Dye Testing Summary

High Level Sewershed

Test ID	Test Type	Date Inspected	Company / Super.	Nearest MH	Ground Condition	Notification Made?
D1028-161	Dye	4/22/2009	ADS/TM	S07WW_010MH	Damp	NA
Address 3510 Liberty Heights Avenue			Location Curb	Status Public	Source Catch Basin

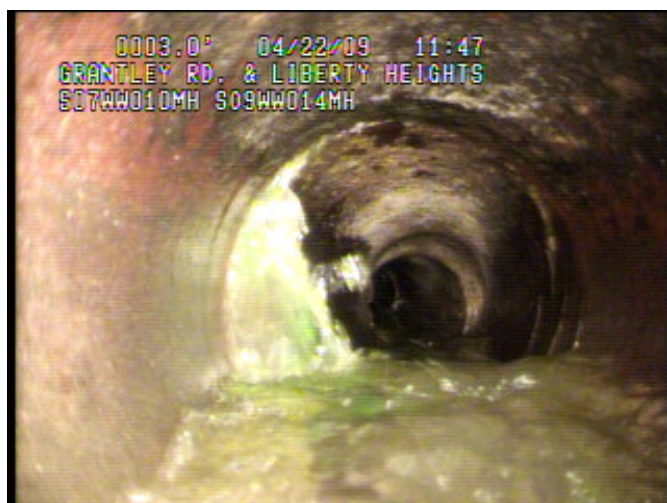
Picture \D1028-161-OB01-P01.jpg

Comments Dye observed 3.0 ft. downstream of S07WW_010MH. Infiltration gusher at joint at 10 o'clock.

Comments 3.0 ft. downstream of S07WW_010MH along S07WW_010G1.

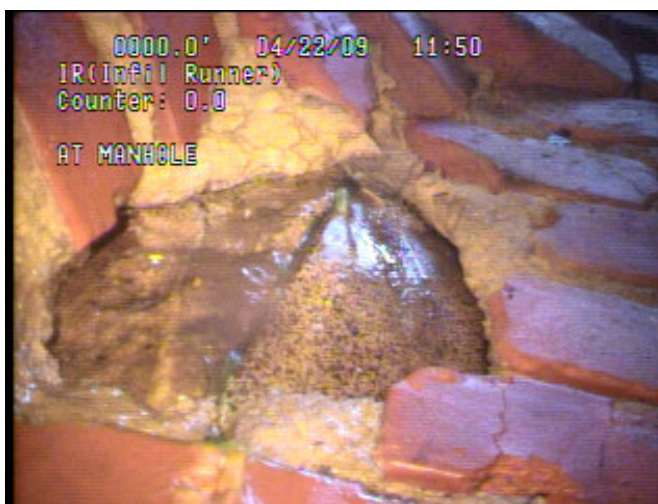
Picture \D1028-161-OB02-P01.jpg

Comments Dye observed in wall of S07WW_010MH. Infiltration runner.

Comments At manhole S07WW_010MH.

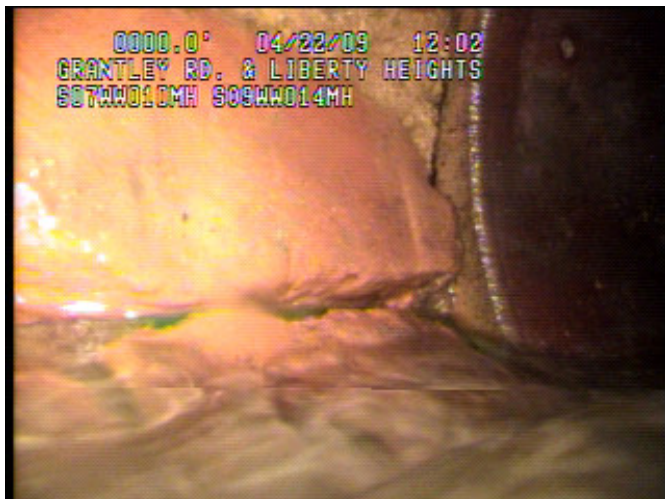
Picture \D1028-161-OB03-P01.jpg

Comments At manhole S07WW_010MH.

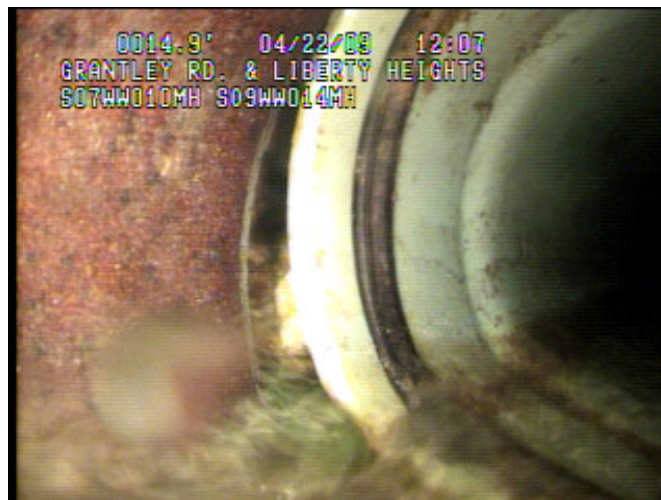
Picture \D1028-161-OB04-P01.jpg

Run Summary								
Test ID	Test Type	Date Inspected	Company / Super.	Nearest MH	Ground Condition	Notification Made?		
D1028-161	Dye	4/22/2009	ADS/TM	S07WW_010MH	Damp	NA		
Address	3510 Liberty Heights Avenue		Location	Curb	Status	Public	Source	Catch Basin
Obs_ID	D1028-161-OB03			Obs_ID	D1028-161-OB04			
Nearest MH	S07WW_010MH			Nearest MH	S07WW_010MH			
Comments	Dye observed in bench of S07WW_010MH. Infiltration runner.			Comments	Dye observed 14.9 ft. downstream of S07WW_010MH. Infiltration runner at joint at 8 o'clock.

Comments 14.9 ft. downstream of S07WW_010MH along S07WW_010G1.
